FIRST CANADIAN PLACE

Peter Kuitenbrouwer: Peeling marble off First Canadian Place fosters Toronto pride

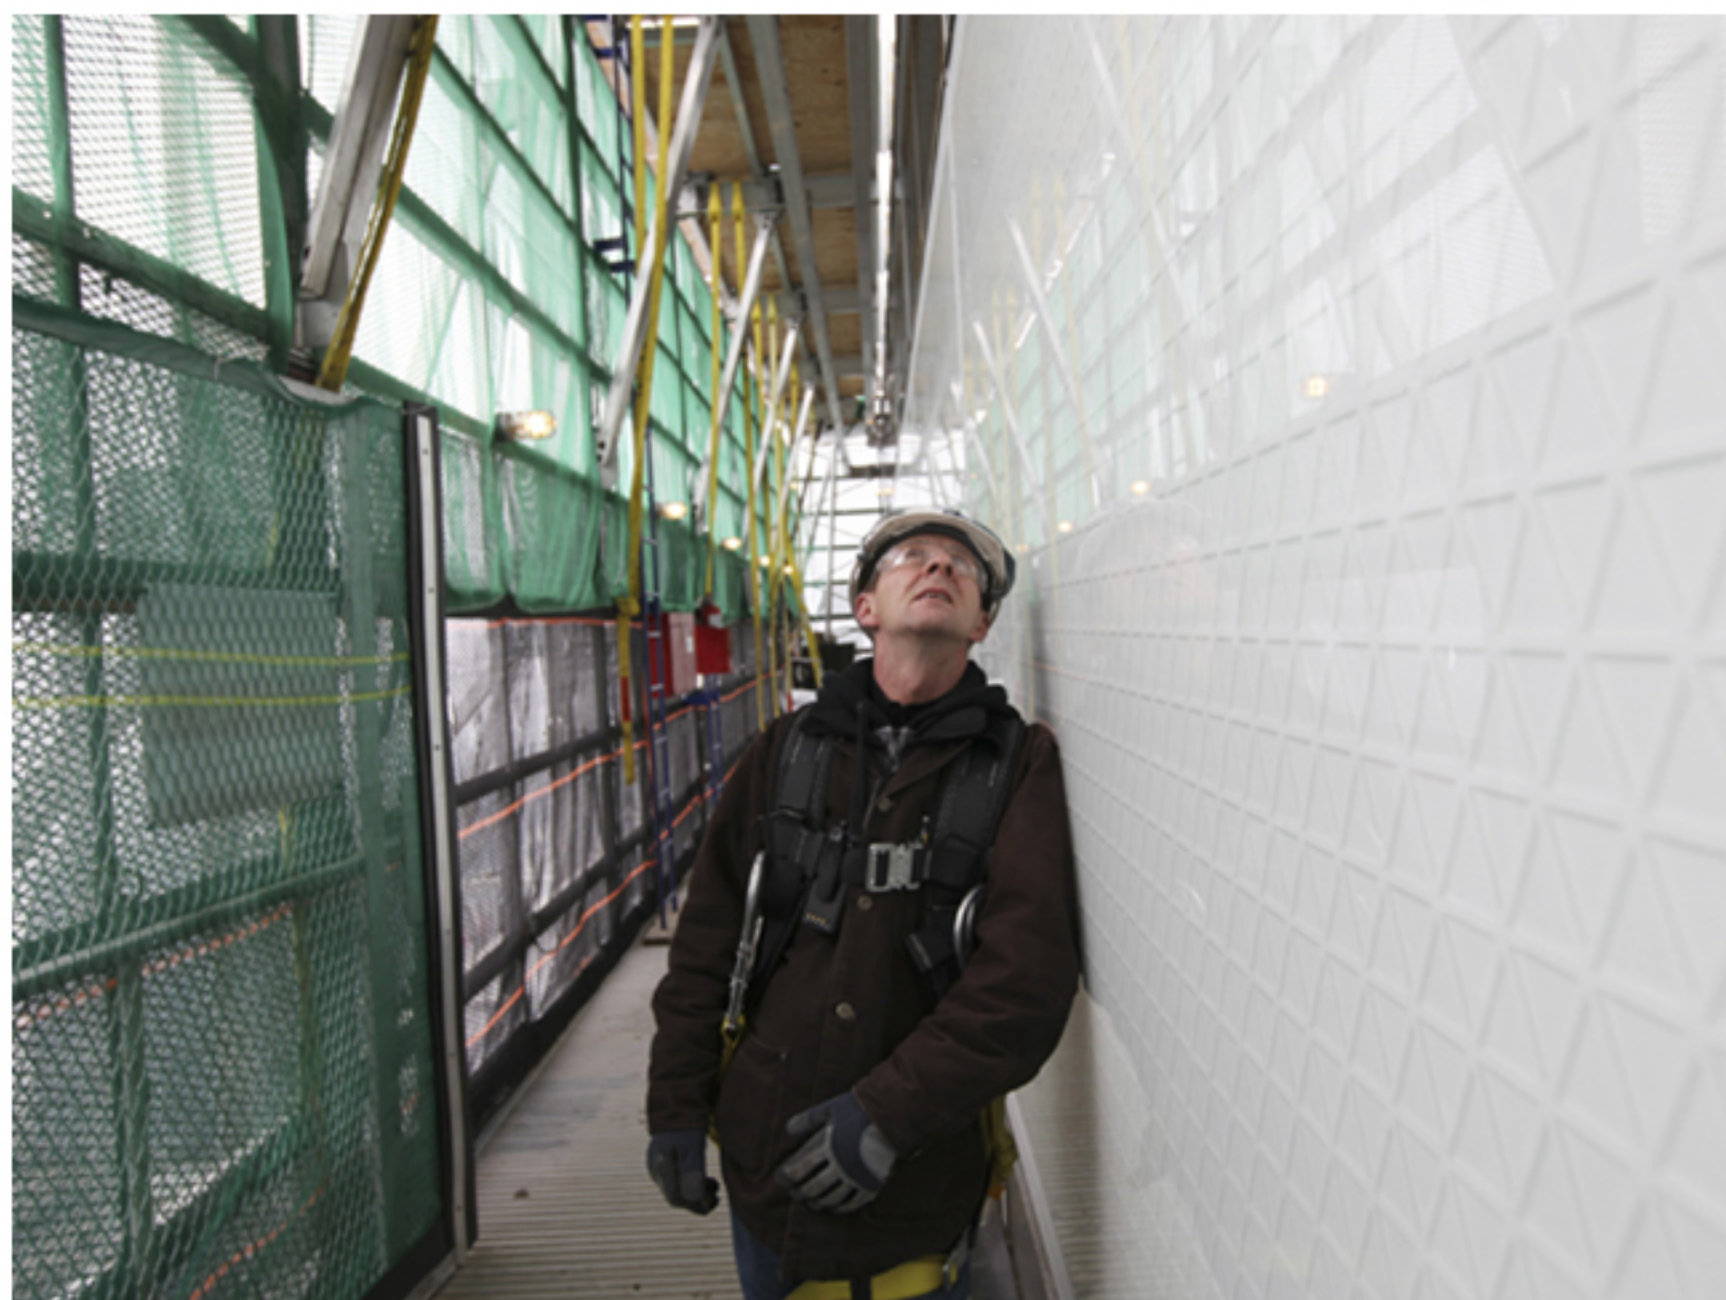
Michael Brodigan examines a panel on the suspended elevated platform, which construction crews are using to replace the marble cladding with glass panels at First Canadian Place. Tyler Anderson/National Post

Workers have hung 14 suspended elevated platforms around the circumference of the building, attached to the roof by cables that run through the window-washer channels. These platforms are three storeys high.

The middle level of the platform is empty; here bolts and turnbuckles affix the work site to the office tower.

On the top platform — the 56th floor, on Thursday — workers with Sota Glazing Inc. use huge steel arms with electric suction cups to affix new 8-foot by 10-foot sheets of triple-layer glass on brackets that steelworkers have attached to the building. Each sheet replaces eight pieces of marble.
